Info Sheet – WHITE RUST Repair & Case Study

JANUARY 2022 | REV 07 | This version supersedes all previous issues

How to Repair White Rust

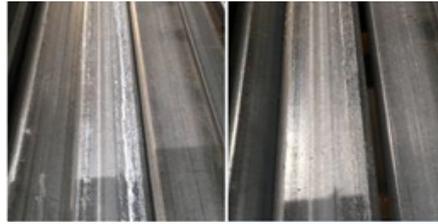
Often early onset staining can be removed or significantly reduced by wiping with a little Kerosene, or vinegar then rinsing with water and drying.

Figure 1: Early staining can be improved by wiping.

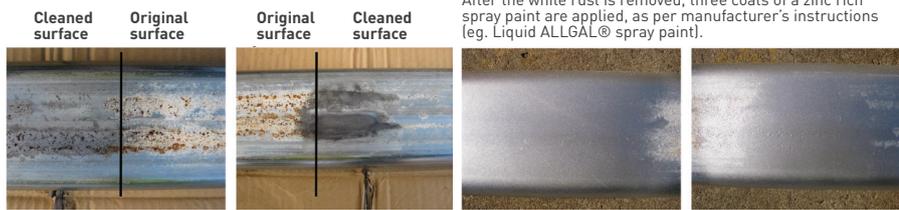
Two methods are shown: rubbing with a nylon scourer (scotch-brite) and vinegar; and mechanical buffing with a wire brush wheel. The effectiveness of each may be seen below.

Figure 2: White rust repair using Vinegar and nylon scourer

Figure 3: White rust repair using Wire brush wheel

Figure 4: Zinc paint repaired (Vinegar/scourer)

Figure 5: Zinc paint repaired (wire brush wheel)

After the white rust is removed, three coats of a zinc rich spray paint are applied, as per manufacturer's instructions (eg. Liquid ALLGAL® spray paint).

Both methods prove equally as effective, but the use of a mechanical wire buffing wheel (or a wire brush) is a lot faster and produces a cleaner surface for re-painting.
